Re: Waiver request for 955 Trail Rd. North
 Lot Addition Plan, for Mark Kleinfelter
 AOA# 24-011

On behalf of the applicant, ACT ONE & Associates respectfully requests the following Waiver of Mount Joy Township's, Chapter 119, Subdivision and Land Development regulations:

- 1) Chapter 119-32.B. Wetland studies.

Exhibit A, Waiver Request
955 Trail Road North
Mount Joy Township
Lancaster County

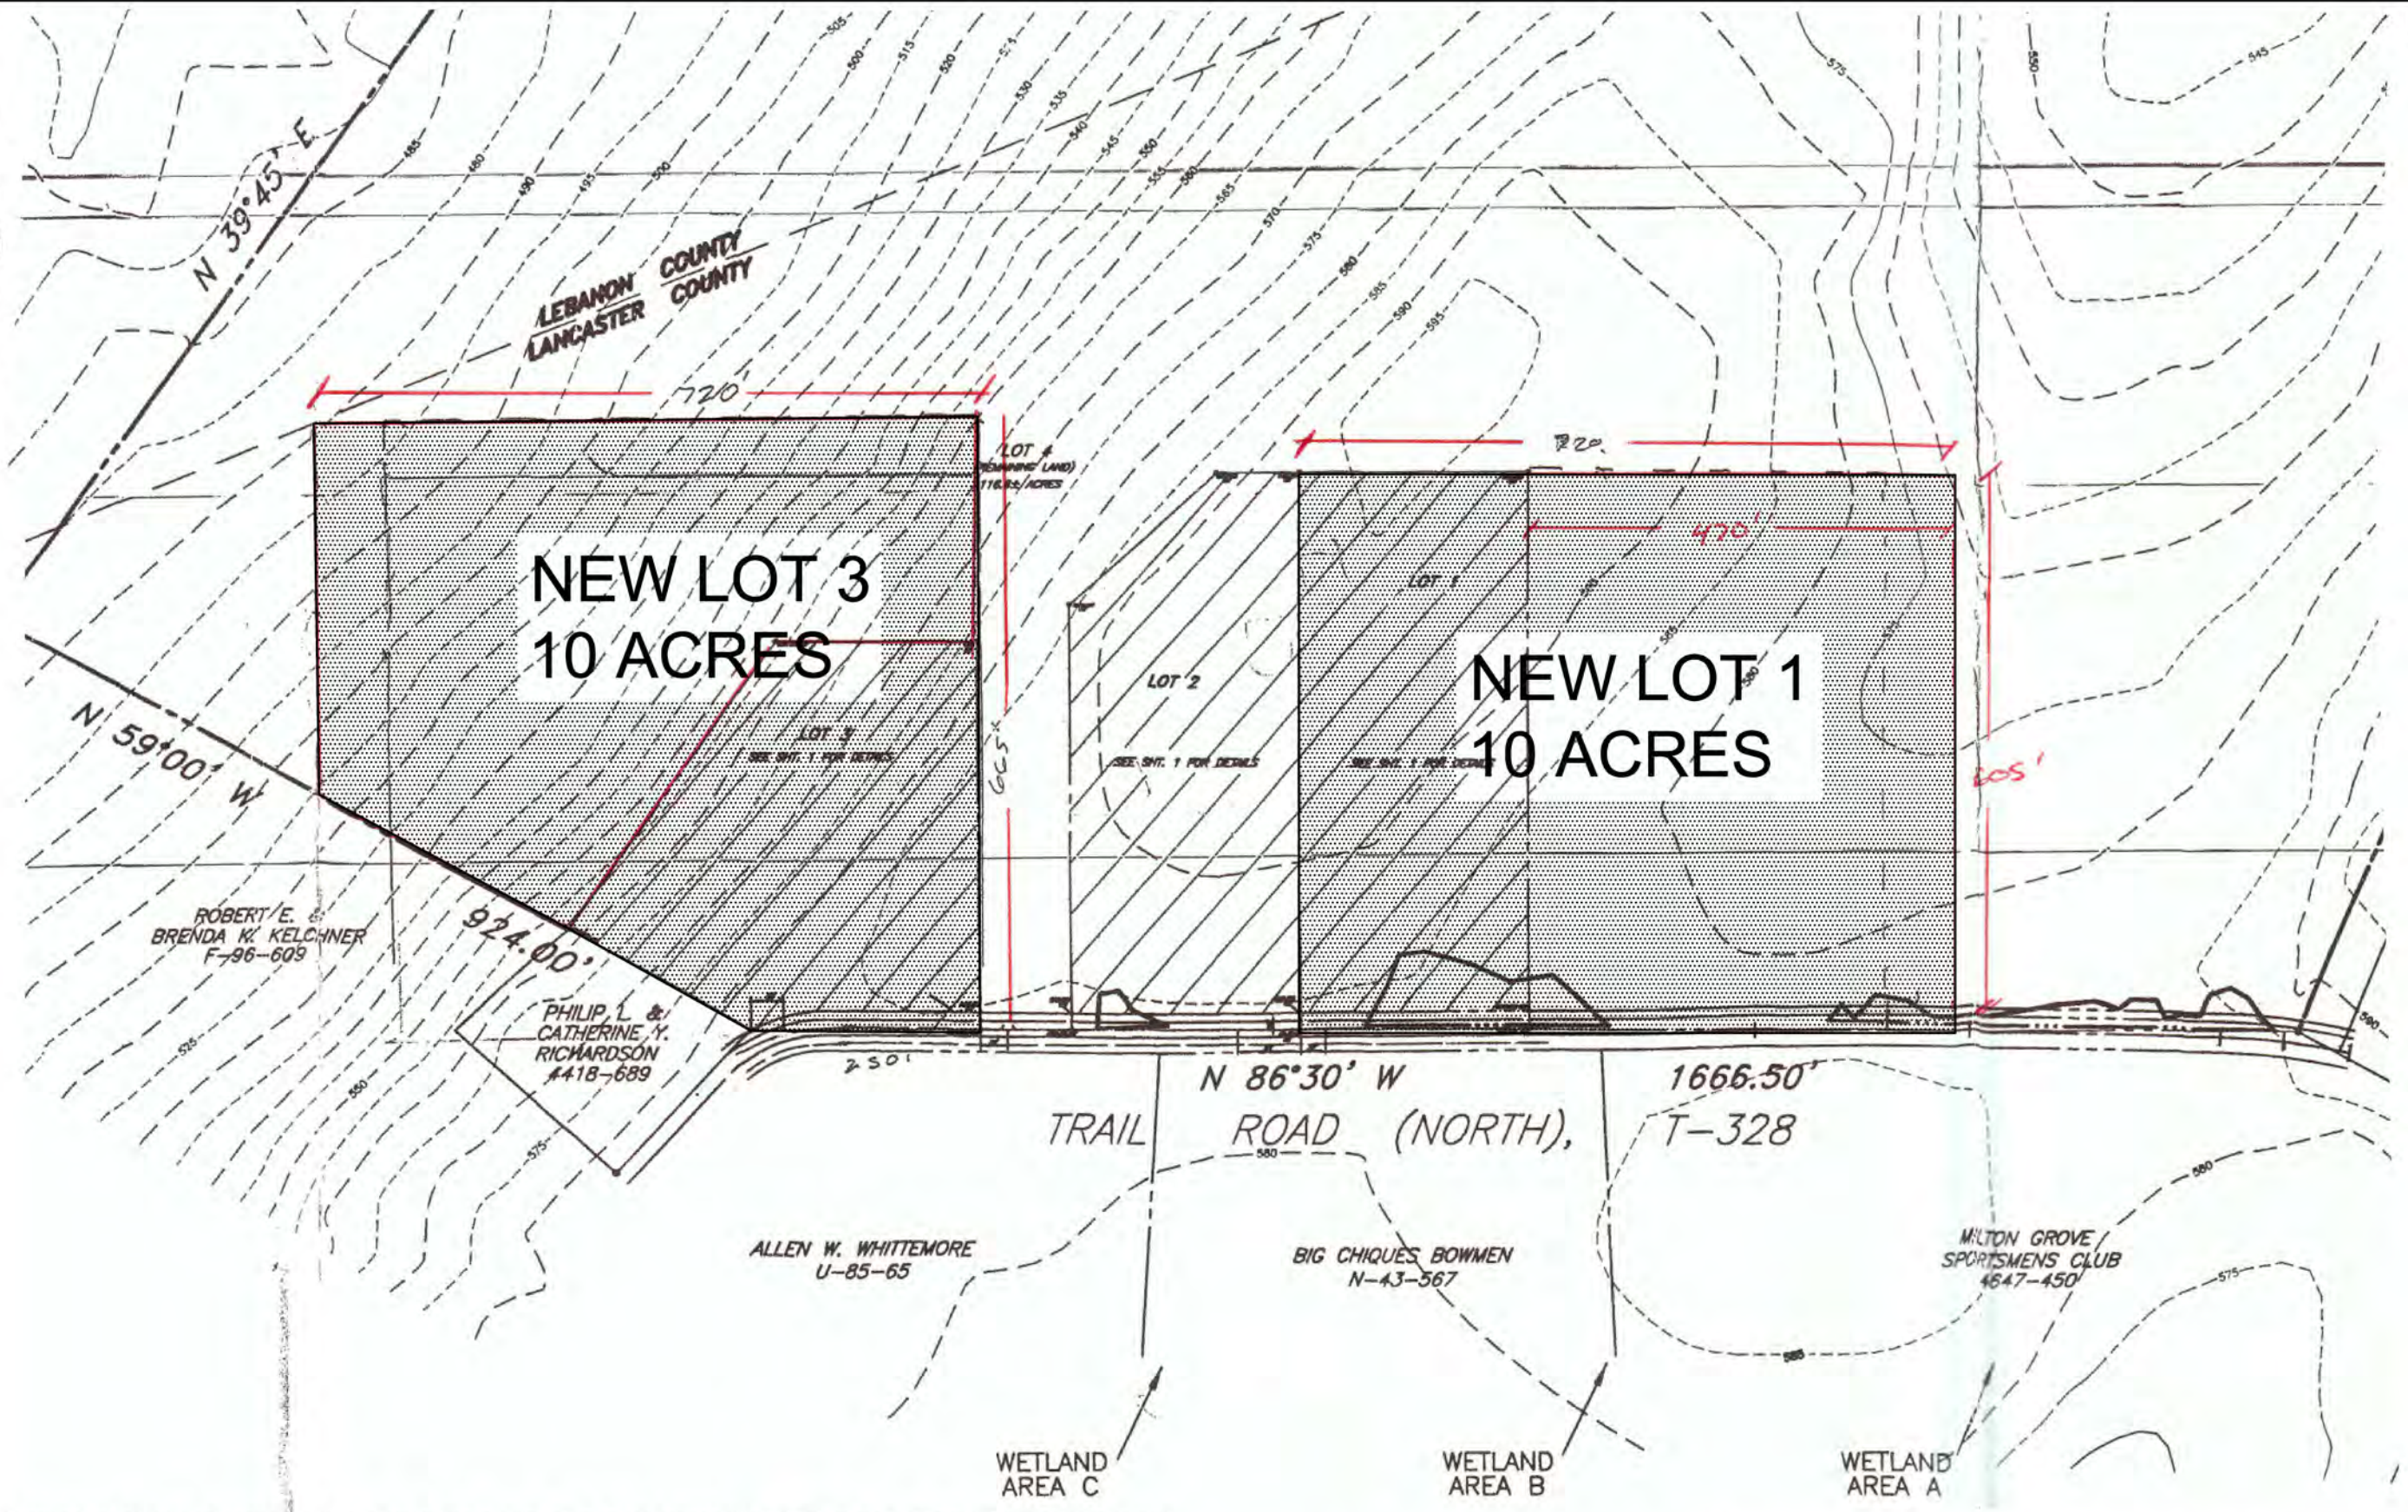
The applicant is requesting relief of the requirements of providing a wetlands study and report in accordance with the abovementioned section of the regulations. The applicant is proposing to submit a Subdivision/Lot Addition Plan for review and approval that will increase the size of 2 parcels (460-2303693-317878-0-0000 & 460-2304312-318372-0-0000) to 10 acres each (clean & green enrollment), while decreasing the size of a third parcel (460-2304572-318948-0-0000) from approximately 116.6 acres to 103.1 acres. No construction or land development is proposed on this new plan. See attached Exhibit A.

Lot #4 on plan J215-47 is currently vacant. The proposed layout of the potential single-family dwelling shown on this plan is well clear of any potential wetlands, and shall be required to submit a stormwater management plan prior to construction, addressing Chapter 113 requirements.

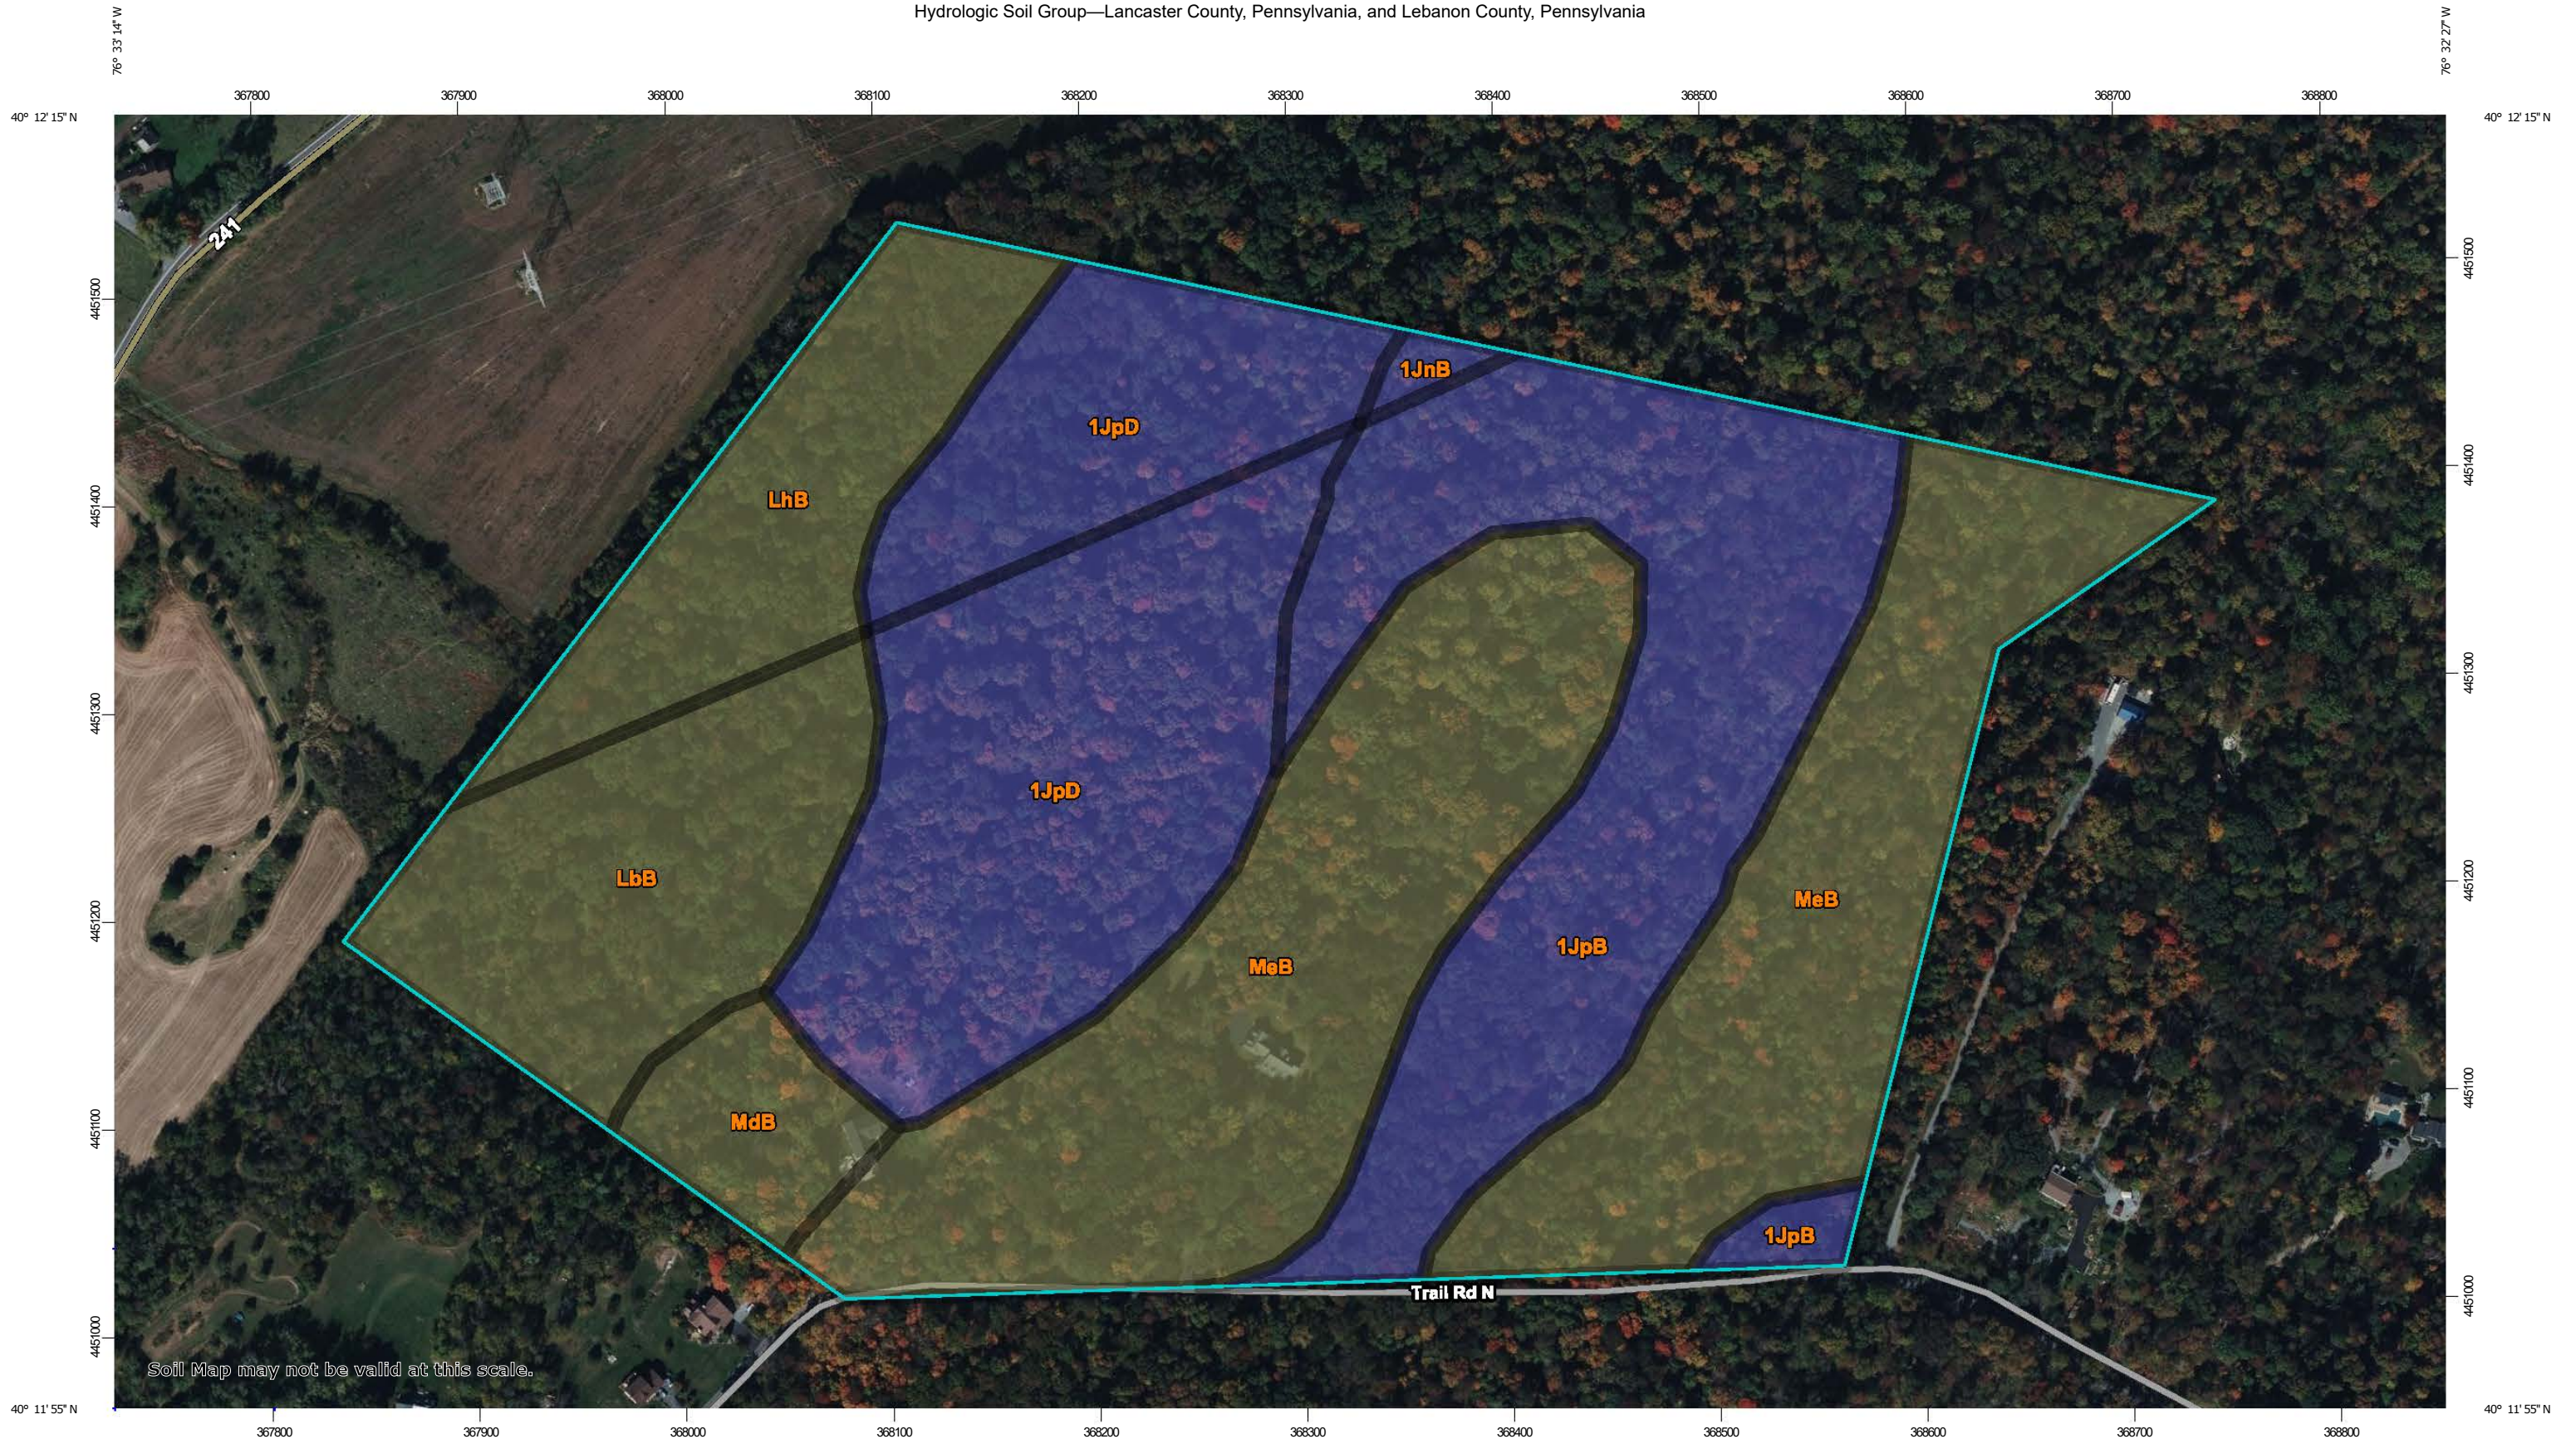
The attached soils mapping from the USDA Web Soil Survey <https://websoilsurvey.nrcs.usda.gov/app/> of Hydrologic Soil Group ratings shows that approximately 44% of the area of interest has a B rating and the remaining is a C/D rating. Per the abovementioned survey Group B soils having a moderate infiltration rate when thoroughly wet. These consist chiefly of moderately deep or deep, moderately well-drained or well drained soils that have moderately fine texture to moderately coarse texture. These soils have a moderate rate of water transmission. Group C soils having a slow infiltration rate when thoroughly wet. These consist chiefly of soils having a layer that impedes the downward movement of water or soils of moderately fine texture or fine texture. These soils have a slow rate of water transmission. If a soil is assigned to a dual hydrologic group (A/D, B/D, or C/D), the first letter is for drained areas and the second is for undrained areas. Only the soils that in their natural condition are in group D are assigned to dual classes. The areas mapped as C/D on this site are drained according to the contouring on plan J215-47. It seems to reason that areas mapped to be potential areas of wetlands (A, B, C) have been influenced by the installation of Trail Road North and driveways, with inadequate, or clogged drainage facilities like swales and culvert pipes.

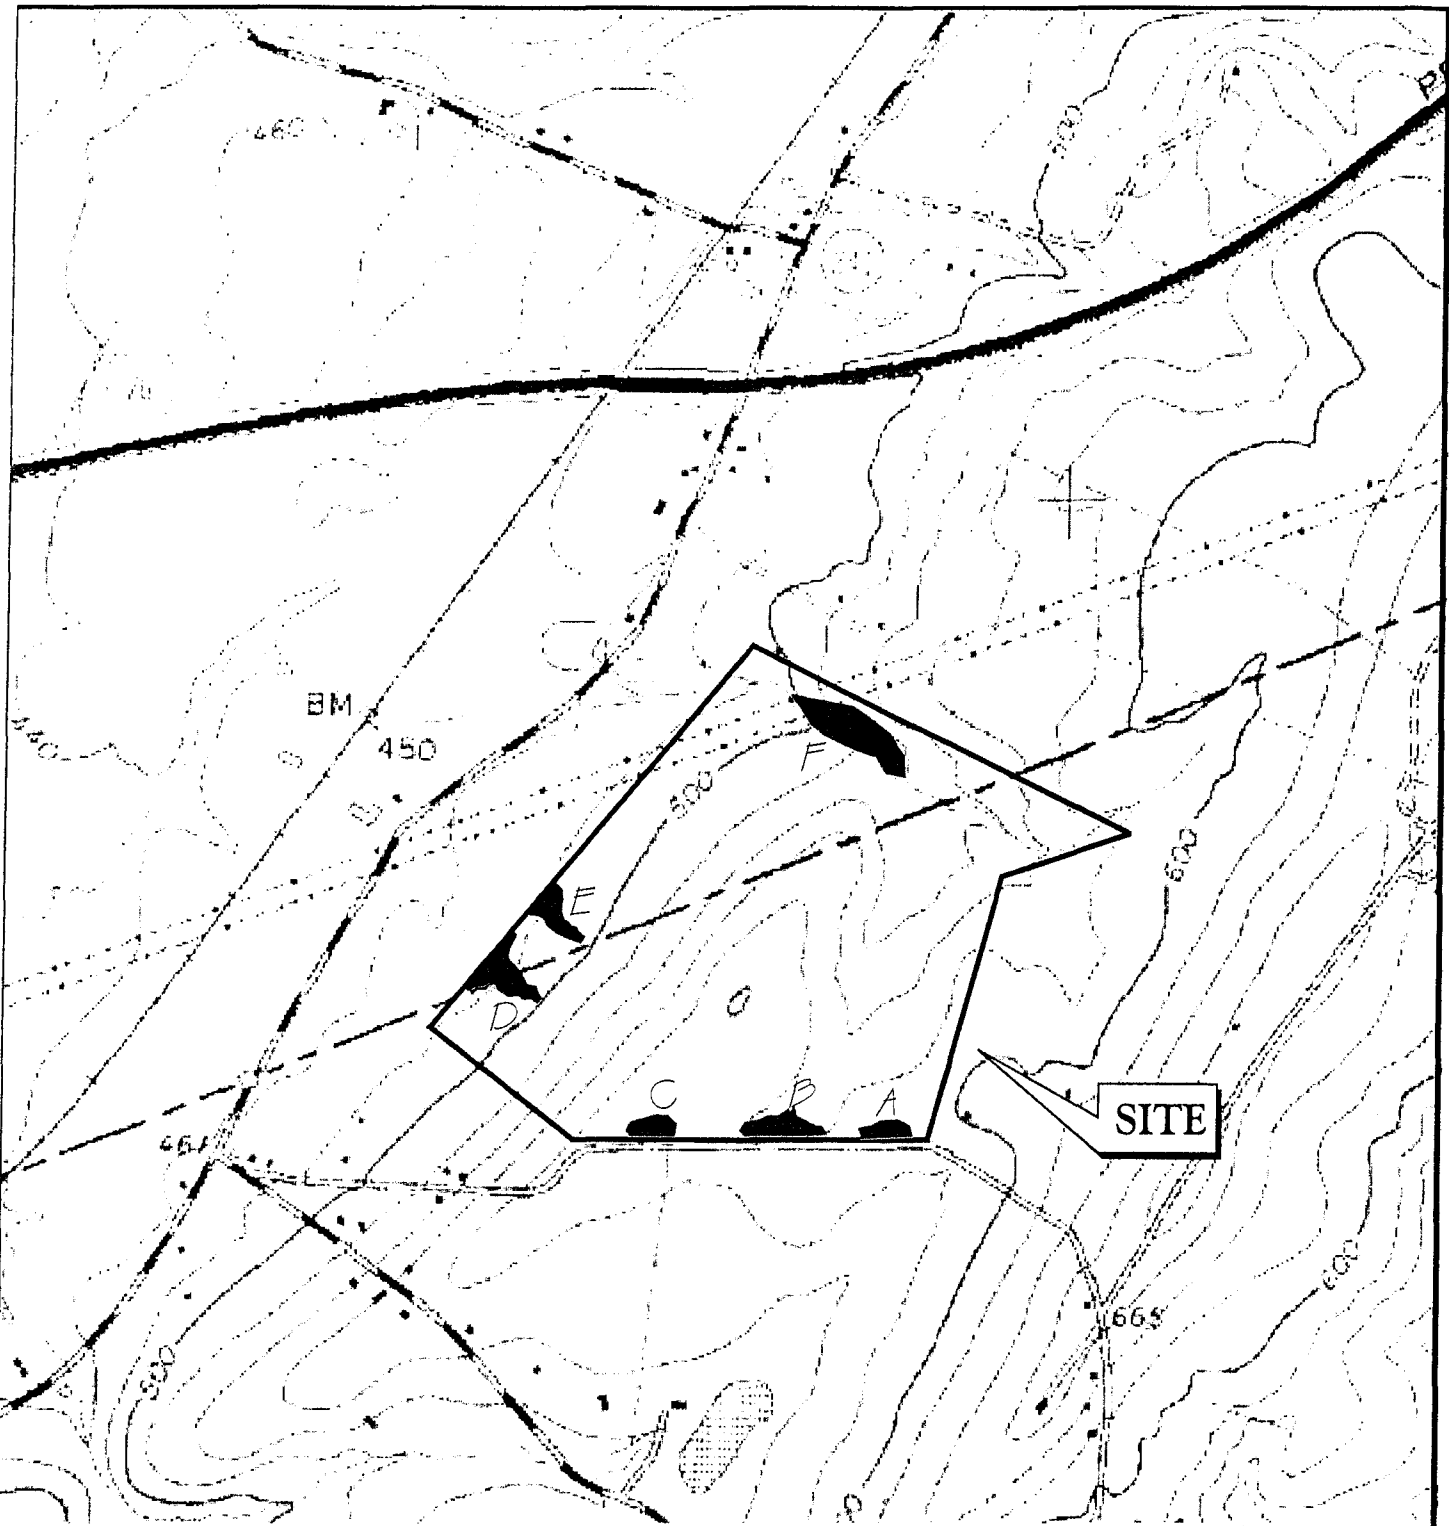
Figure 5

The third indicator of a wetland is the presence of hydrology. Hydrology is often the least exact of the parameters. Wetland hydrology includes all hydrologic characteristics of areas that are periodically inundated or have soils saturated to the surface at some time during the growing season. These are areas where the presence of water has an overriding influence on characteristics of vegetation and soils due to anaerobic and reducing conditions. Topography of the site, based on the site visit and in conjunction with the USGS quadrangle mapping Elizabethtown, PA, 1964, Photorevised 1990, indicates that the property is generally flat along Trail Road, slopes steeply down toward the north from Trail Road toward Lebanon County. The west side of the site slopes down toward the west. Surface drainage is to the unnamed tributary, which flows generally west through the property in the northeastern section of the site. Wet areas of the site related to hydrology were identified by shallow water, of other indicators, and used to identify the wetlands areas A through F on Figure 5.

Based on published information and a site visit, several possible wetland areas were identified on the Kleinfelter property. (Figure 5) Three of the six-wetland areas (A, B and C) are along Trail Road, which may make site access a potential issue. Wetland areas E and D are found in the southwestern section of the site and are split by the Lebanon and Lancaster County lines. Wetland F is in the northwestern section of the site and encompasses the unnamed tributary. Although mapped soils may be marginal or pose severe limitations for on-site sewage disposal due to wetness, slow percolation, slope, or depth to rock, the potential of satisfactory locations are possible due to the topography and possible hydrology over the immediate site area.

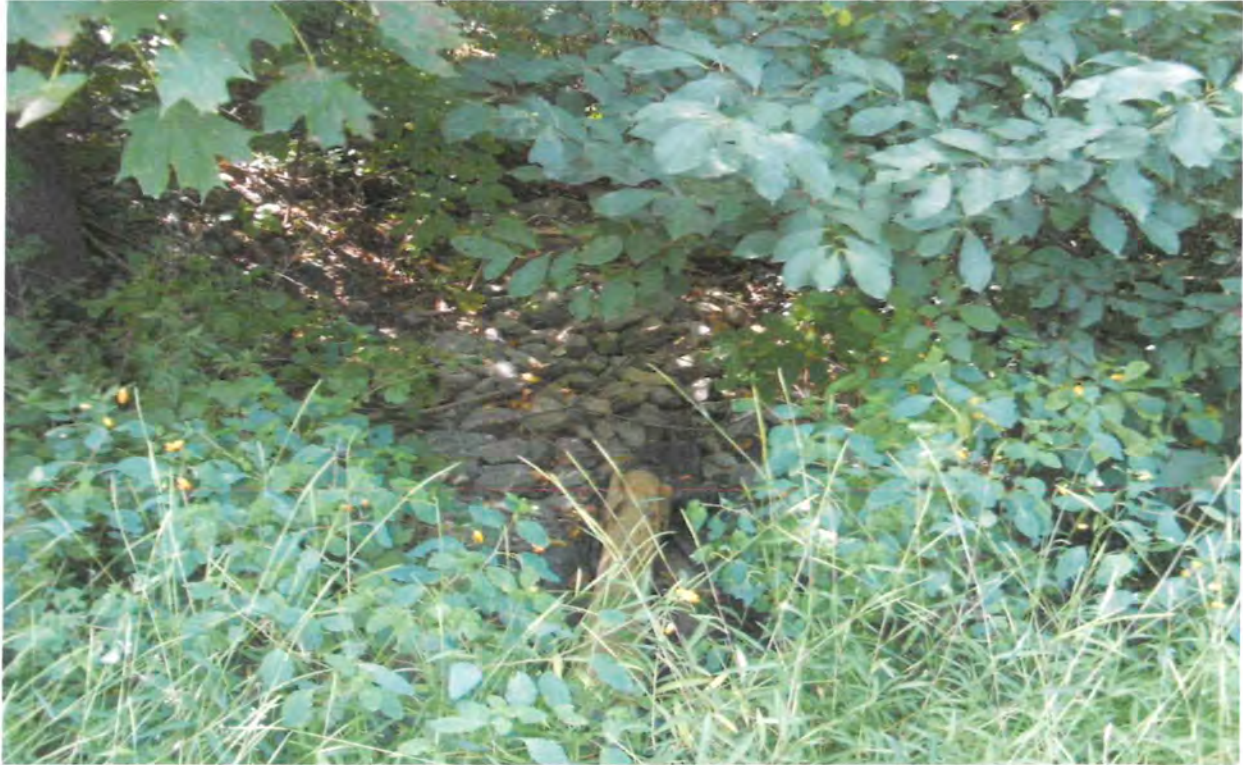
channel (Watercourse 1 – UNT to the Conewago Creek) was observed in the east-central portion of the linear study area. This intermittent stream channel originates at the culvert outfall along Trail Road North and drains to the southwest. Wetland 1 is located across the roadway from this stream channel and provides supporting hydrology. Hydrology within the extreme western portion of the linear study area is generally conveyed via overland sheet flow and existing storm water management facilities to the west, where it flows into the existing storm water management facilities along Milton Grove Road.

Photo C. Southern view of the intermittent stream channel (Watercourse 1 – UNT to the Conewago Creek) at the southern end of the existing culvert under Trail Road North.

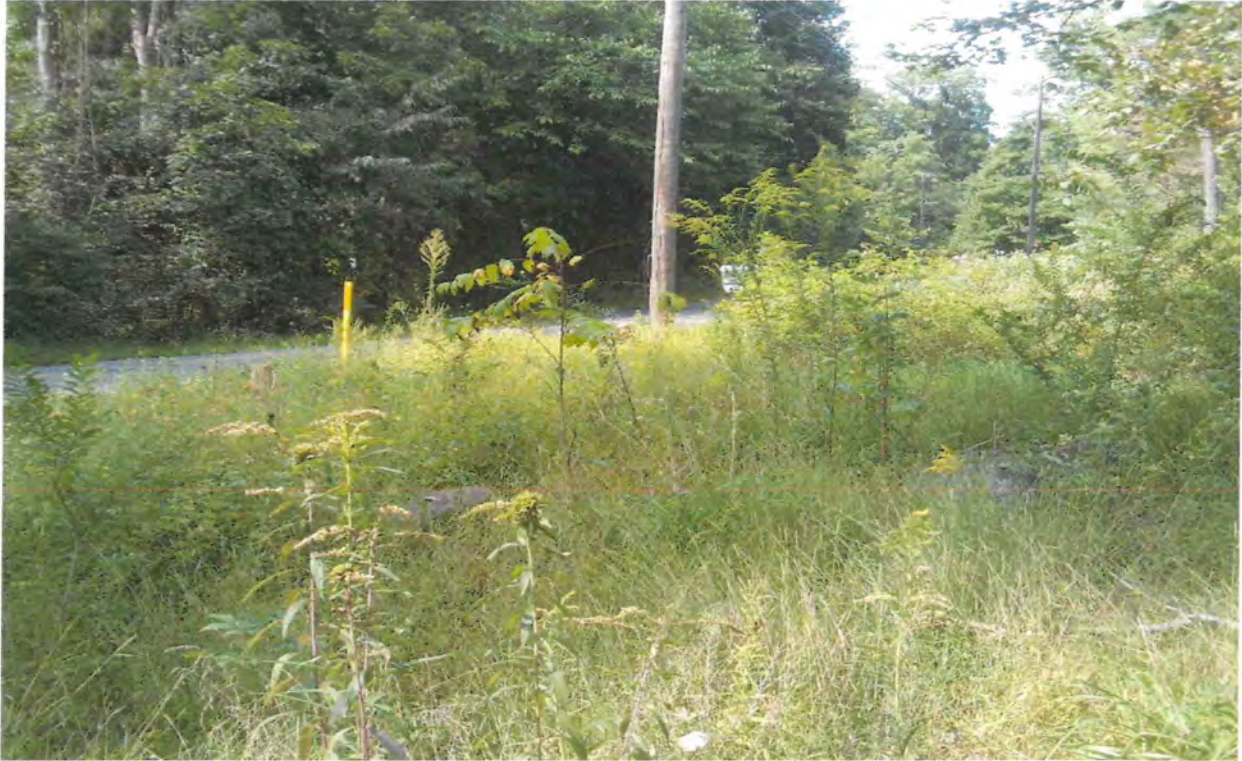
Photo E. Western view of Wetland 1, north of Trail Road North.

The eight (8) wetland areas (Wetlands 1 - 8) were observed within low-lying areas adjacent to the existing roadway. These wetlands are generally situated within the central portion of the linear study area. These eight (8) wetland areas are supported by seasonal high groundwater elevations, overland drainage from the adjacent uplands, stormwater drainage from the adjacent roadway, low-lying topography and poorly drained soils. Primary indicators of wetland hydrology observed within the wetland areas included saturation in the upper 12 inches, water marks, water-stained leaves and oxidized root channels in the upper 12 inches of the soil profile. Secondary indicators of wetland hydrology included wetland drainage patterns and geomorphic position.

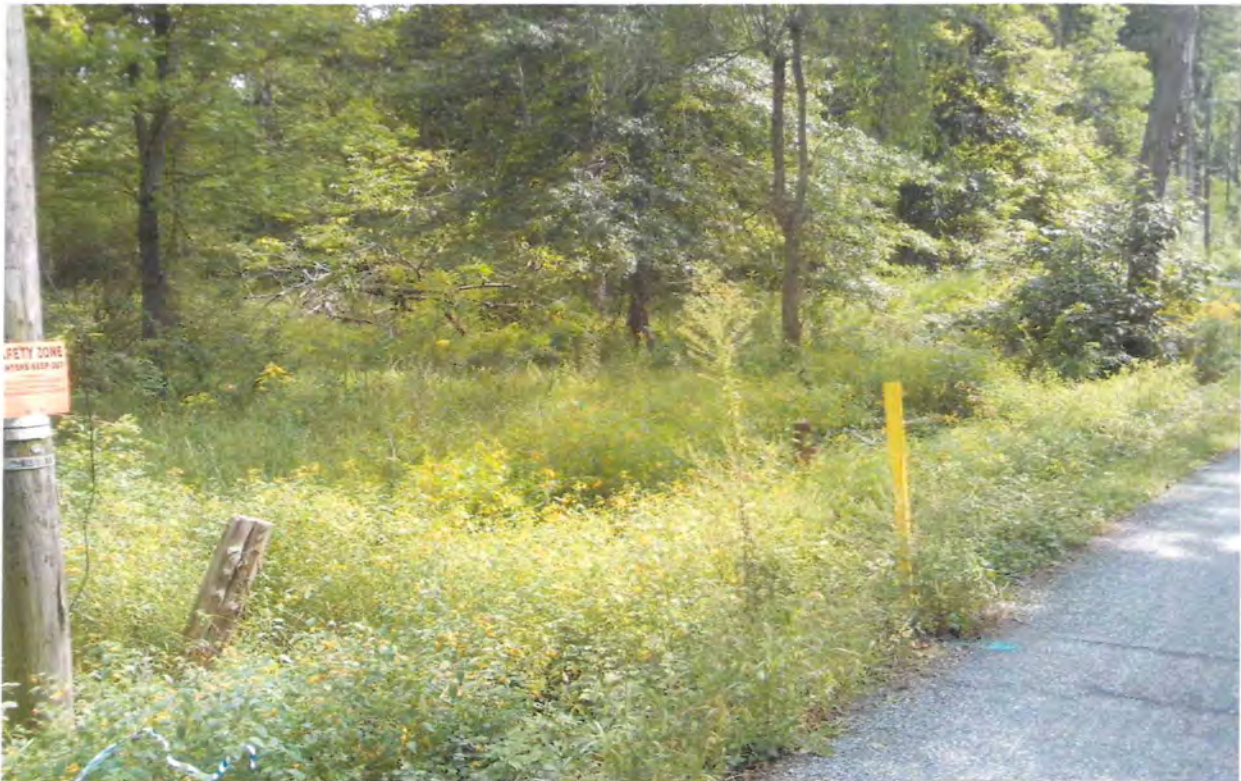
Photo F. Eastern view of Wetland 1, north of Trail Road North.

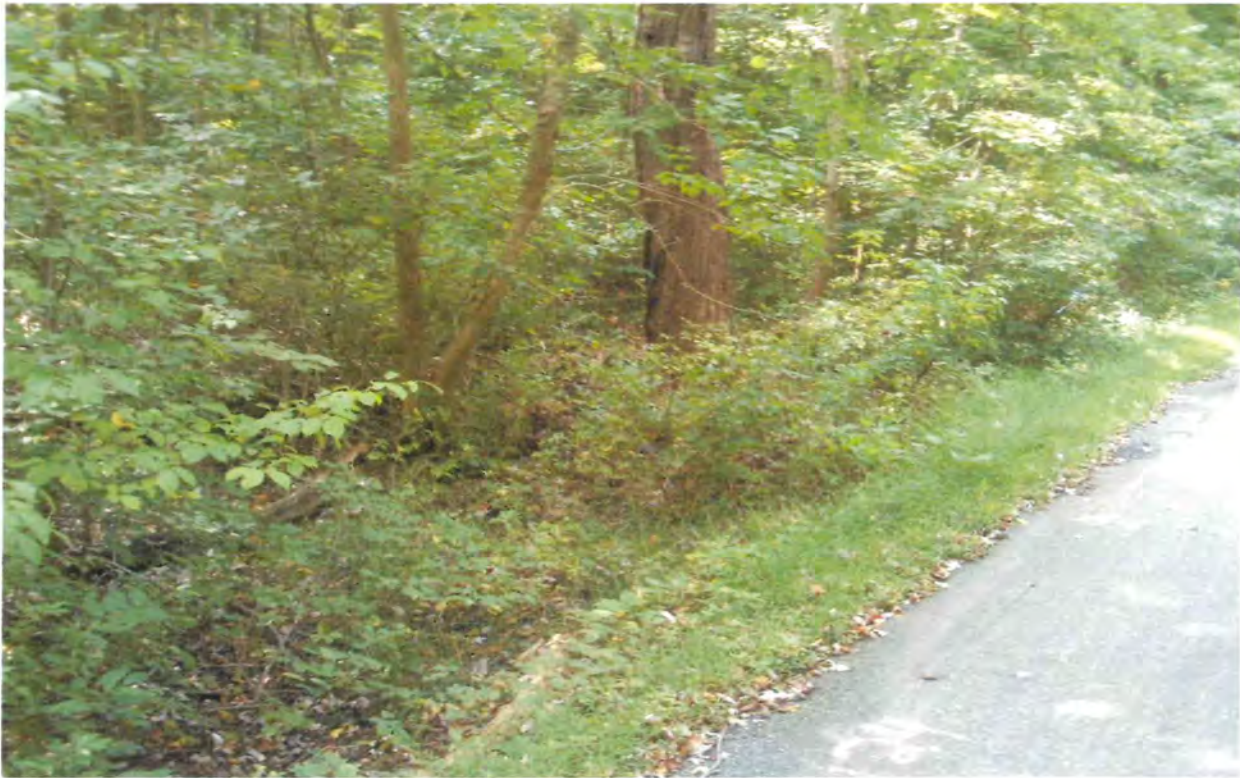
Photo H. Northeastern view of Wetland 3, north of Trail Road North.

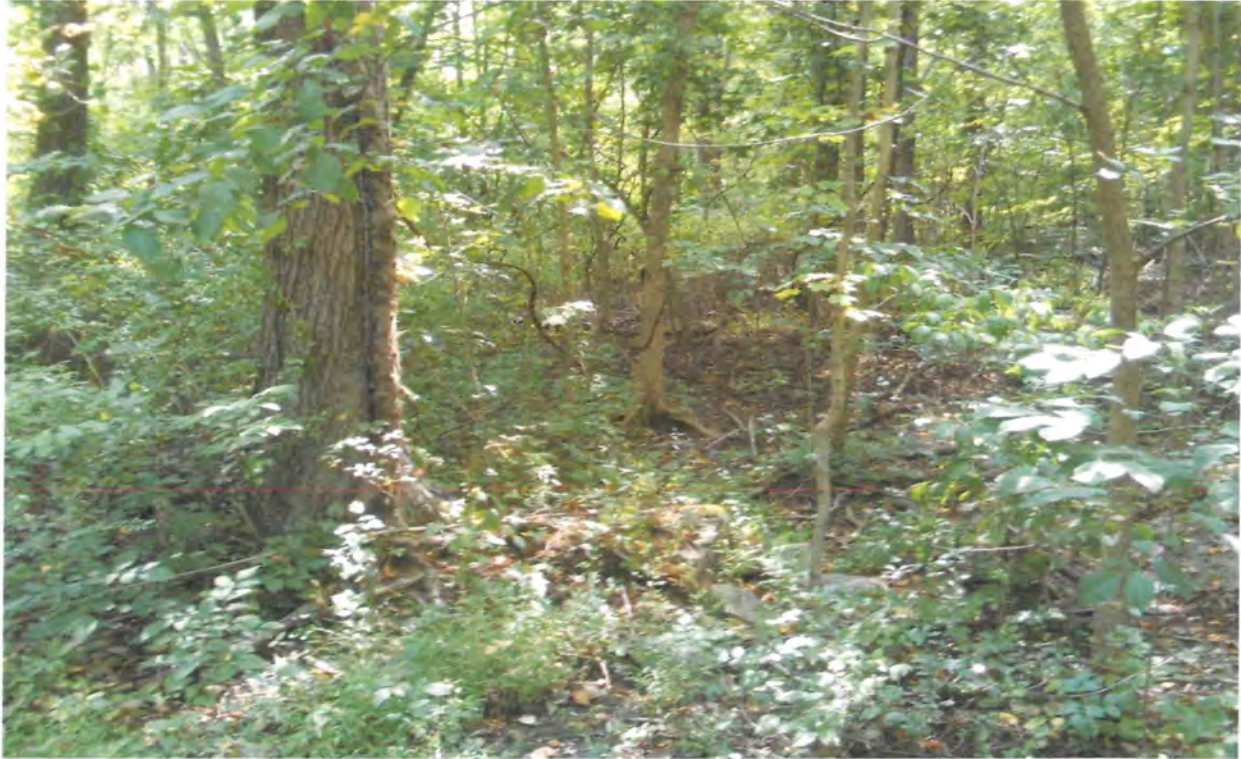
Photo I. Northwestern view of Wetland 3, north of Trail Road North.

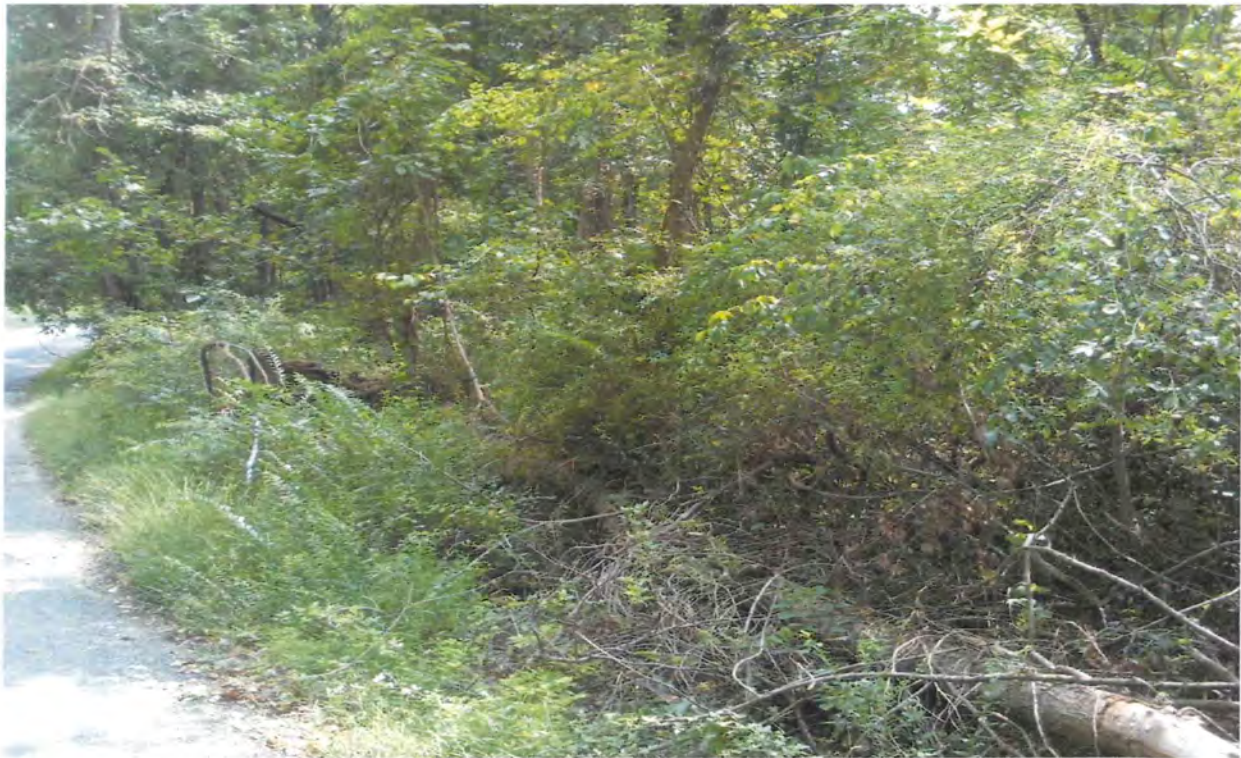
Photo J. Southeastern view of Wetland 2, south of Trail Road North.

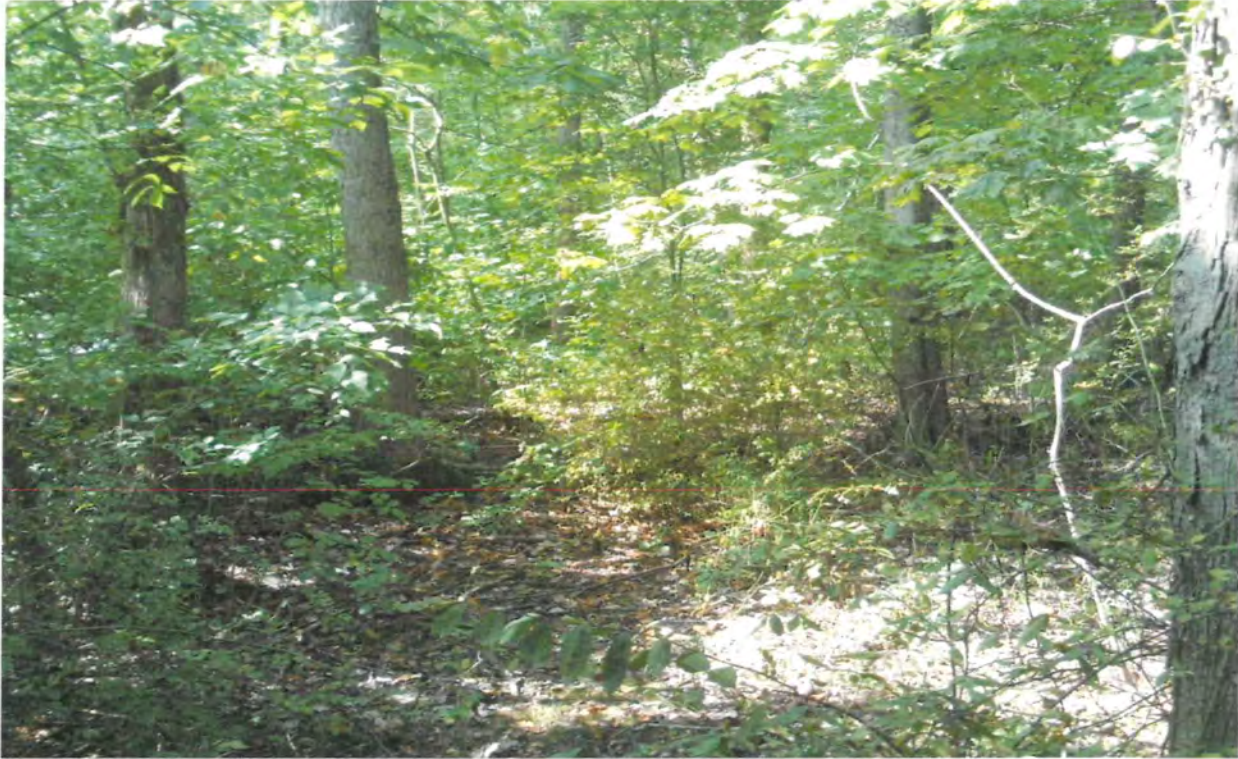
Photo K. Southern view of Wetland 2, south of Trail Road North.

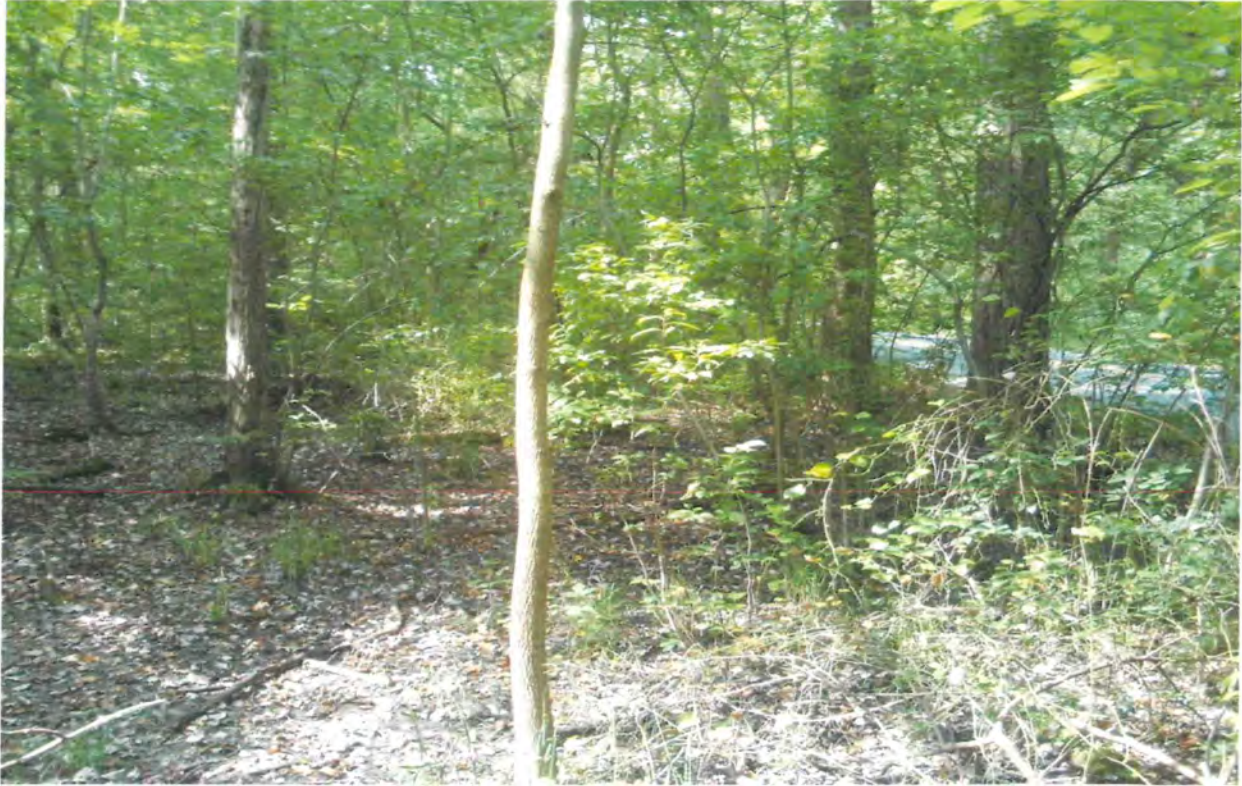
Photo M. Western view of Wetland 4, south of Trail Road North.

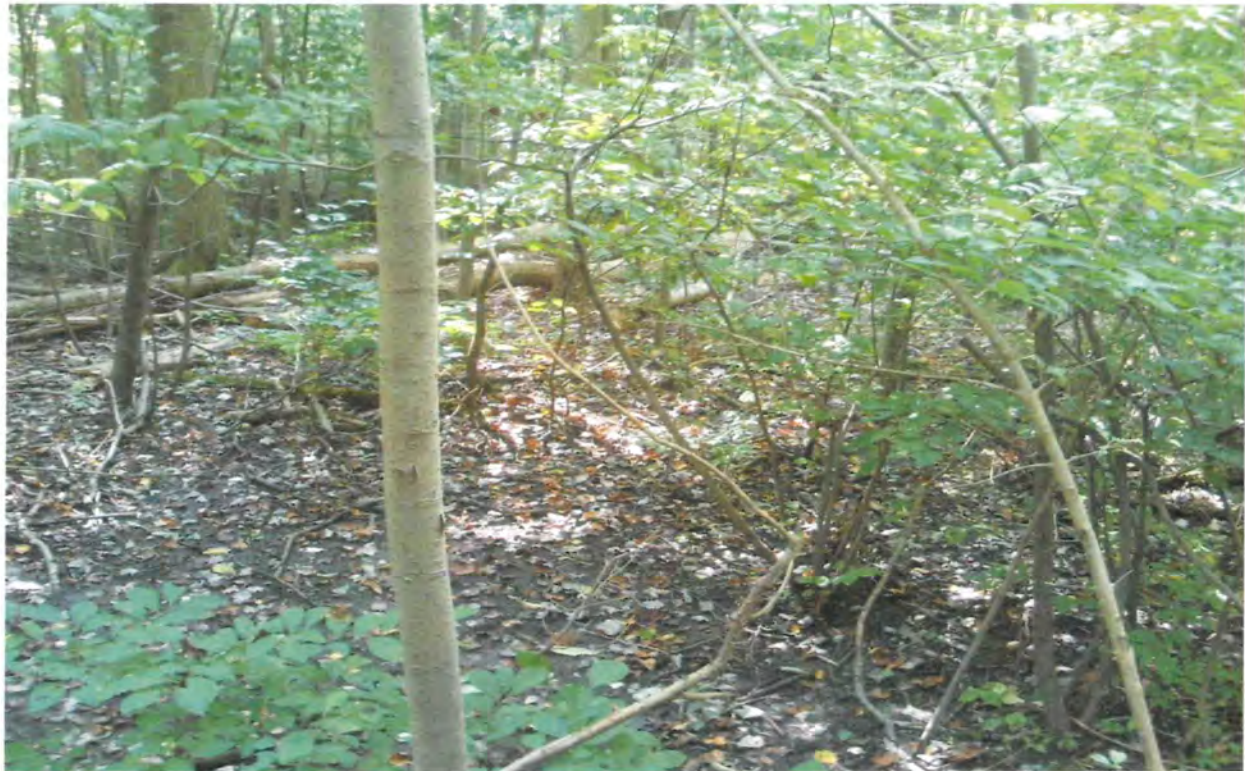
Photo N. Northern view of Wetland 5, north of Trail Road North.

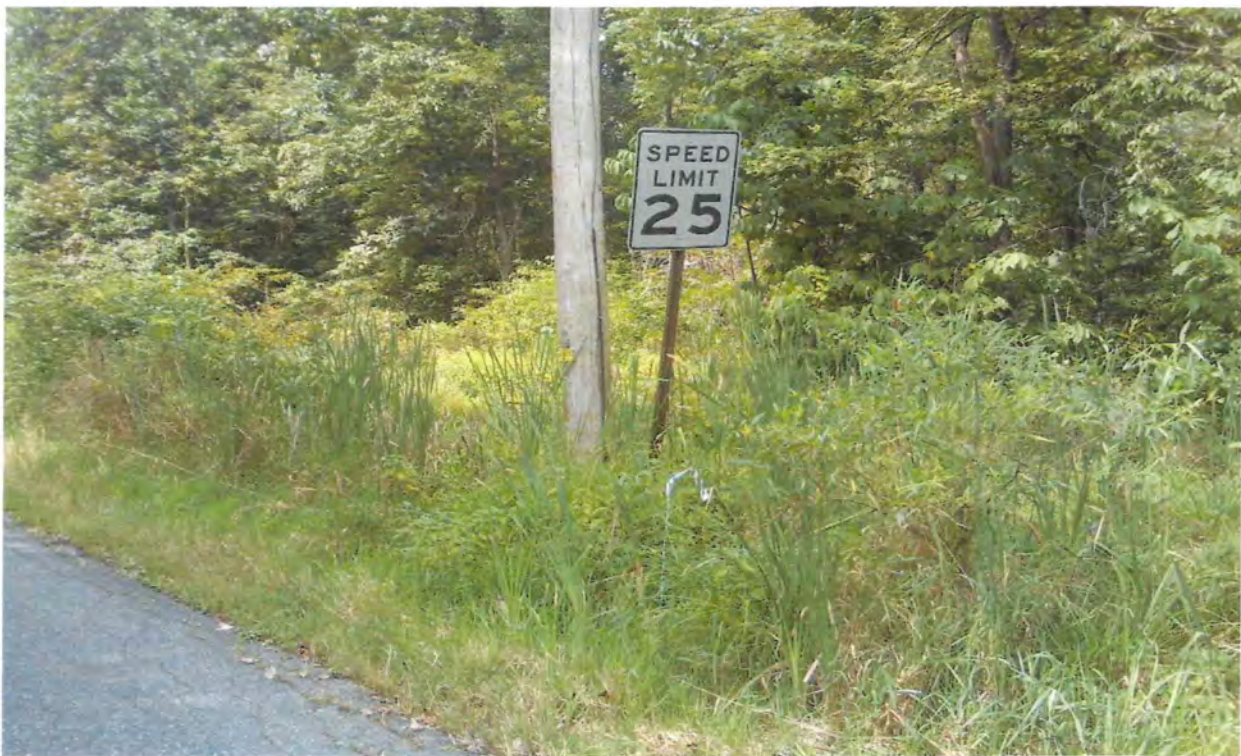
Photo P. Northwestern view of Wetland 7, north of Trail Road North.

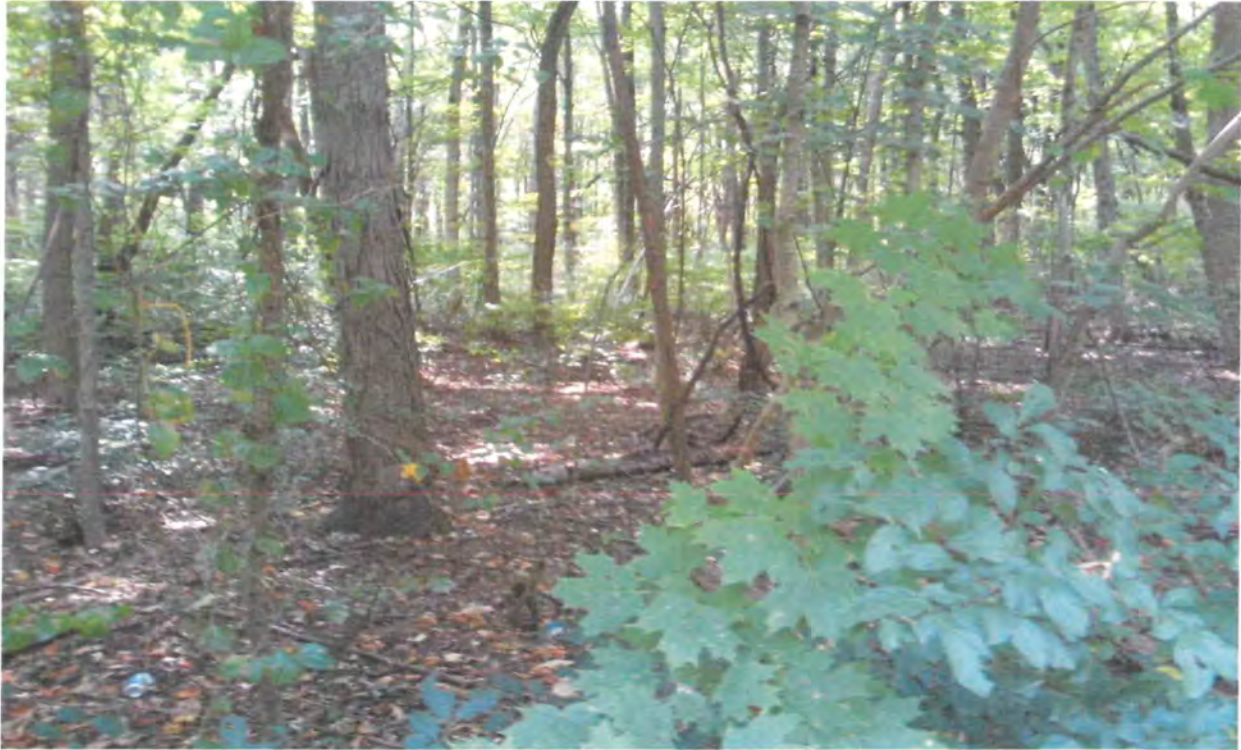
Photo Q. Southern view of Wetland 6, south of Trail Road North.

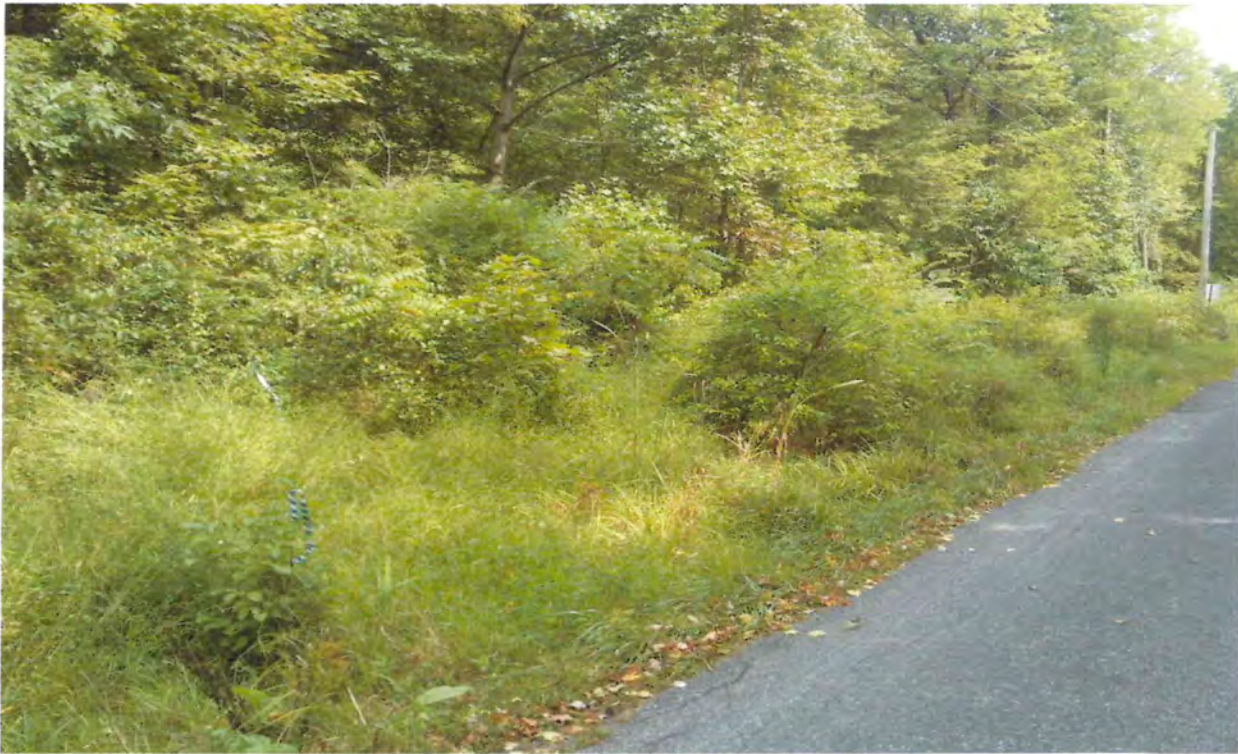
Photo R. Northeastern view of Wetland 7, north of Trail Road North.
