Re: Waiver request for 955 Trail Rd. North
 Lot Addition Plan, for Mark Kleinfelter
 AOA# 24-011

On behalf of the applicant, ACT ONE & Associates respectfully requests the following Waiver of Mount Joy Township's, Chapter 119, Subdivision and Land Development regulations:

- 1) Chapter 119-32.B. Wetland studies.

Exhibit A, Waiver Request
955 Trail Road North
Mount Joy Township
Lancaster County

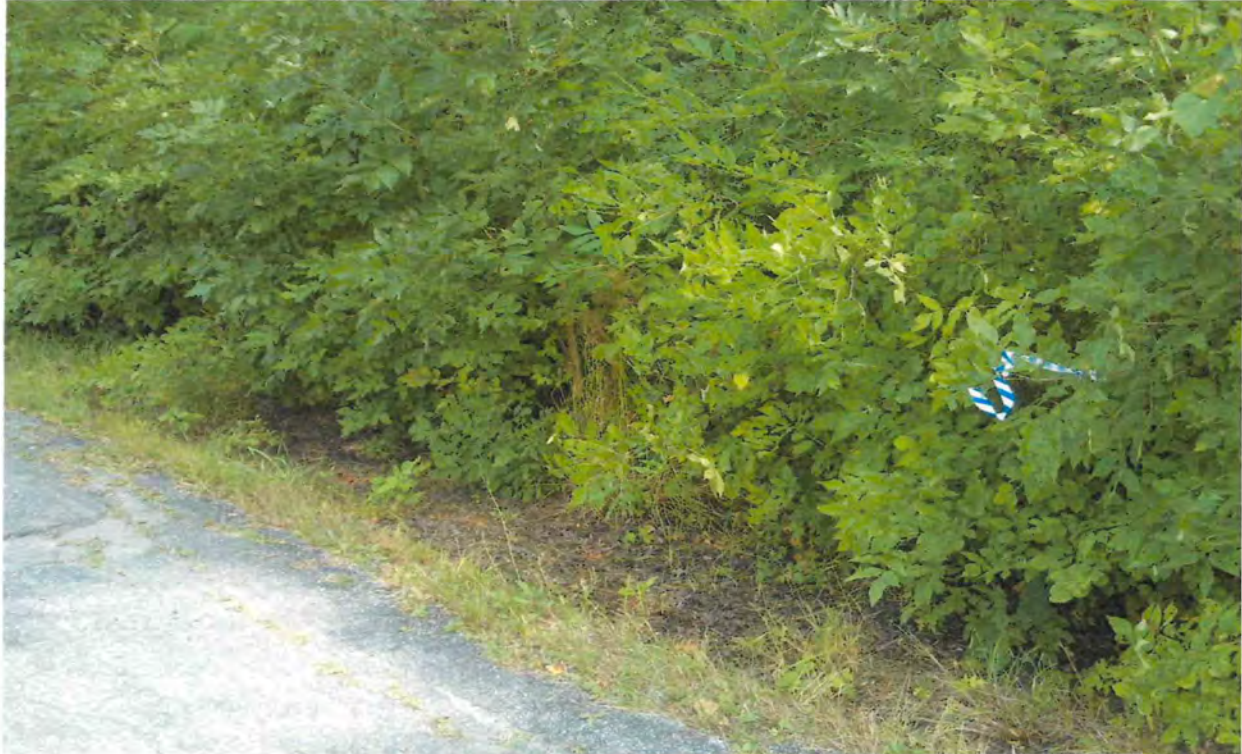
Photo T. Southeastern view of Wetland 8 to the south of Trail Road North.

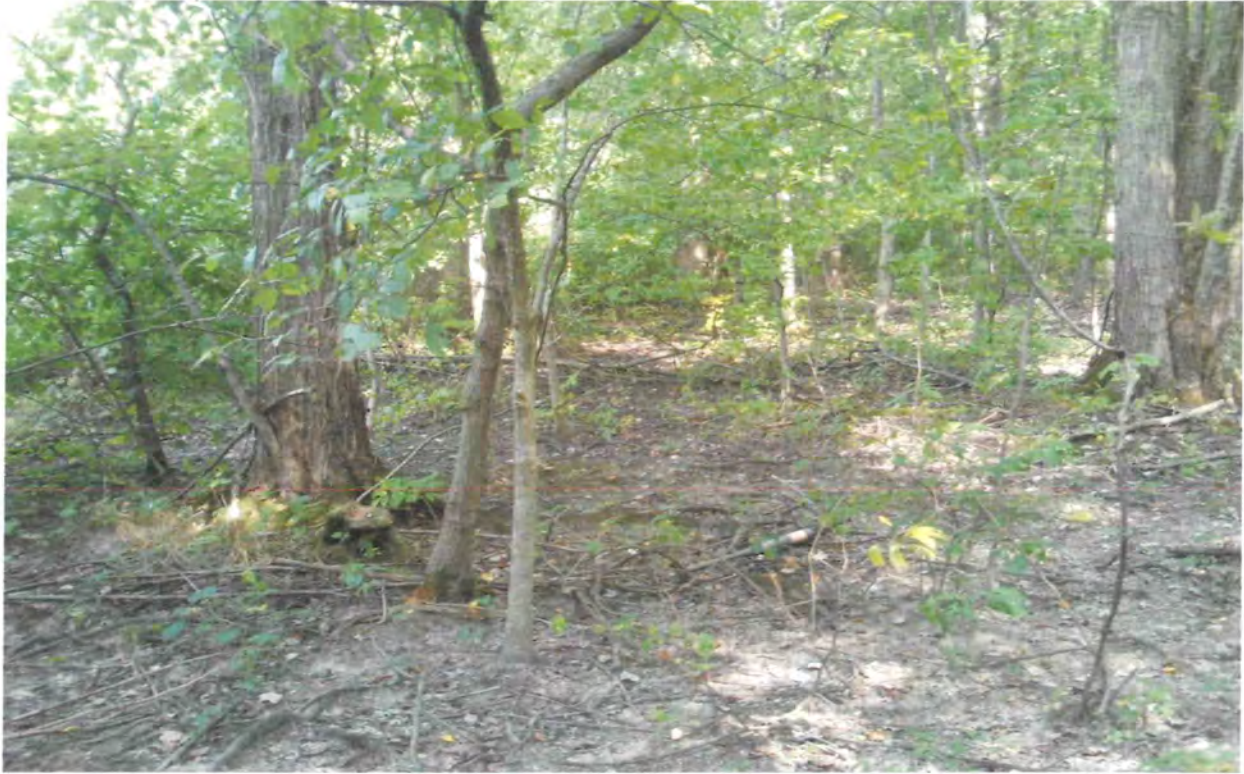
Photo U. Southwestern view of Wetland 8 to the south of Trail Road North.
